Manhole Inspection Summary

Manhole # S47G2_016MH

Insp Date: **1/22/08 1:40 PM**

Location Address: **4221 Curtis Ave.**

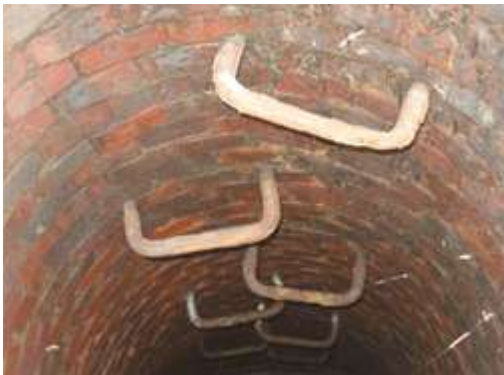
Steps

Count: **9** Missing: **0** ☐ Corroded

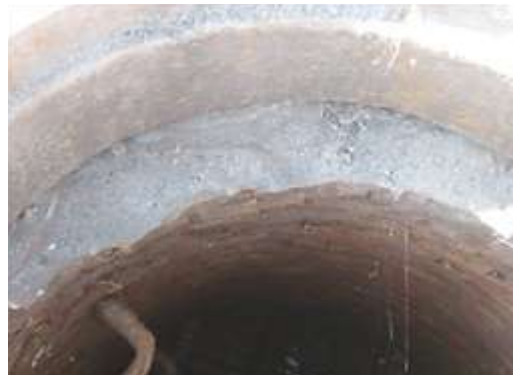
Defect 1

Offset: **3** (in.)

Frame offset

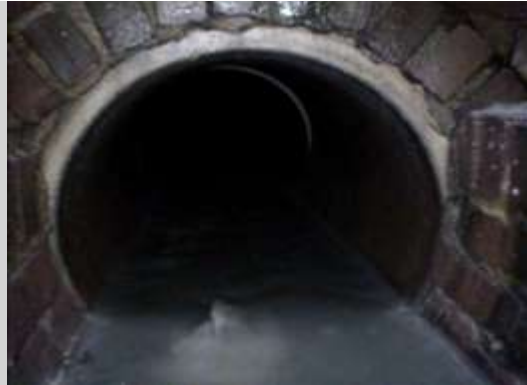
12 O'Clock Outflow

18 in. Circular Gravity Sewer
Pipe Out @ 12 O'Clock

Pipe Height: **18** (in.) Rod and Bar (Angled)
Pipe Material: **Clay** ☐ Pipe Lined
Invert Depth: **15.51** (ft.) Flow Characteristics: **Fast**
Deposits: ☒ None ☐ Mud ☐ Sludge ☐ Debris ☐ Grease
Silt Depth: (in.) Deposits Extent:
Infiltration: **None** Pipe Seal Cond: **Sound**

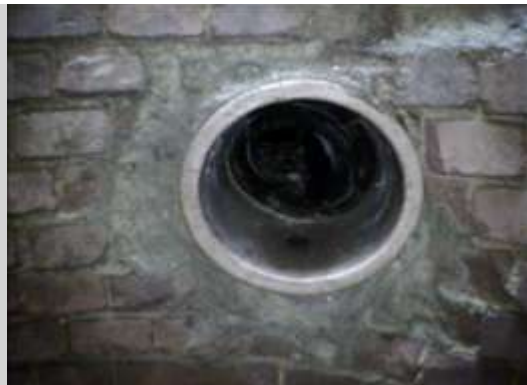
2 O'Clock Inflow

8 in. Circular Service Sewer
Pipe In @ 2 O'Clock

Pipe Height: **8.4** (in.) Rod and Bar (Angled)
Pipe Material: **Clay** ☐ Pipe Lined
Invert Depth: **10.18** (ft.) Flow Characteristics: **None**
Deposits: ☒ None ☐ Mud ☐ Sludge ☐ Debris ☐ Grease
Silt Depth: (in.) Deposits Extent:
Infiltration: **None** Pipe Seal Cond: **Sound**

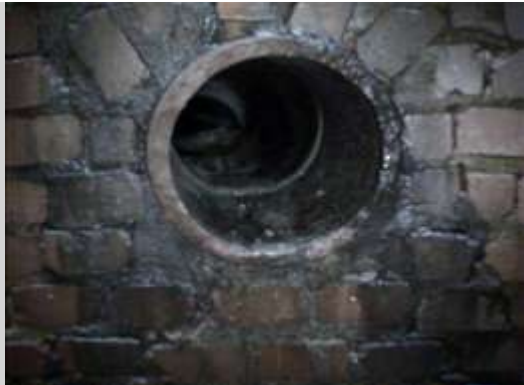
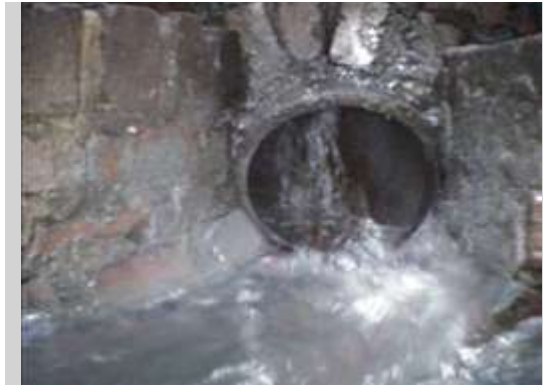
3 O'Clock Inflow

Pipe In @ 3 O'Clock

Drop In @ 3 O'Clock

Infiltration: **None** Pipe Seal Cond: **Sound**

Drop: **Outside** Rod and Bar
Angled: **Yes** Reading: **14.42** (ft.)
Inv Depth: **15.42** (ft.)
Drop Condition: **Open**

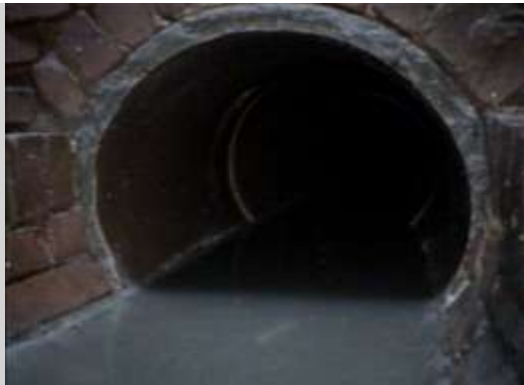
6 O'Clock Inflow

Pipe In @ 6 O'Clock

Infiltration: **None** Pipe Seal Cond: **Sound**
